# Dedicated Home Services LLC

**This is an actual inspection of a newly constructed home**

Aaron Pfaff, Dedicated Home Services LLC

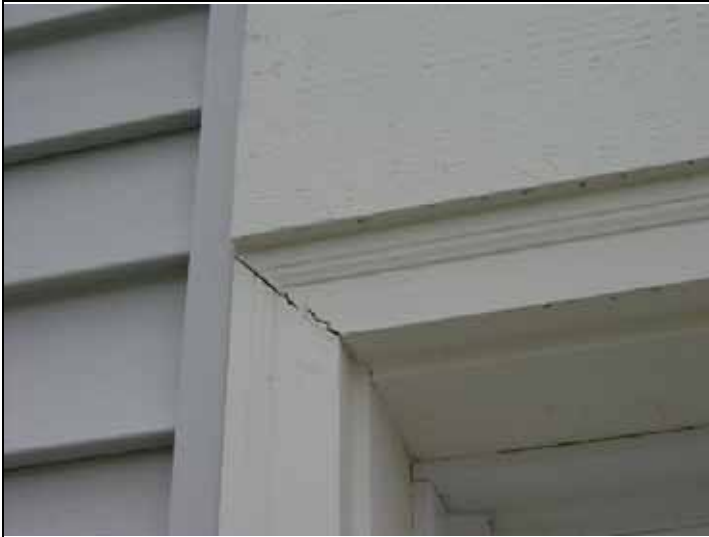
Caulk wood trim

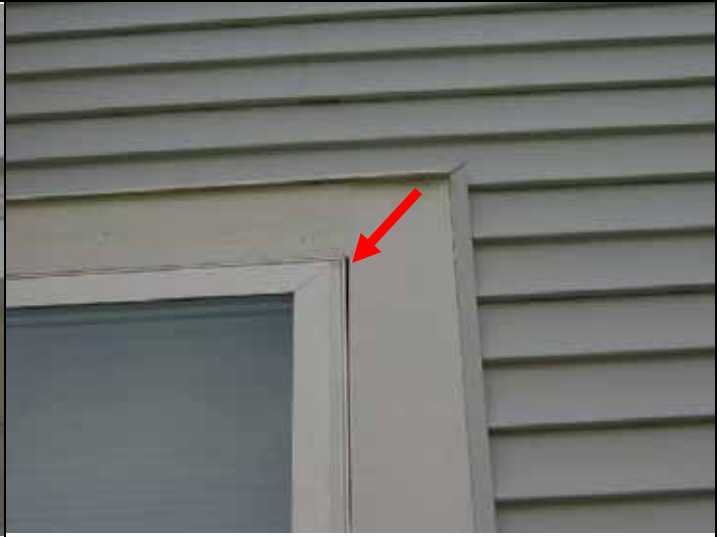
Caulk around windows

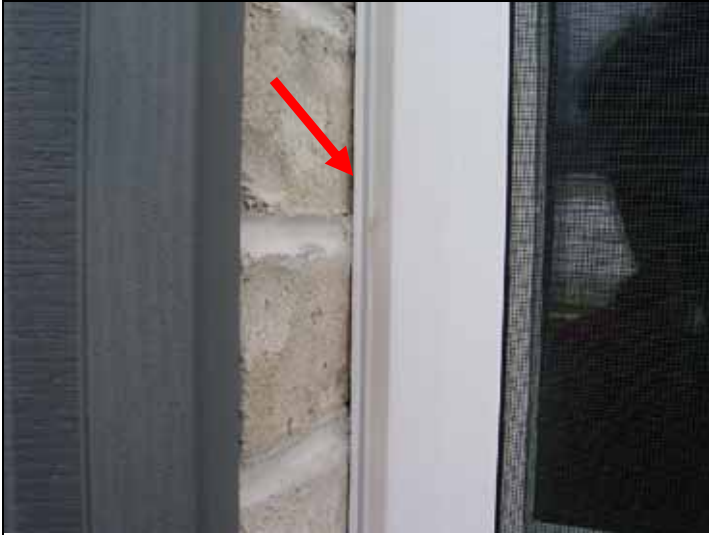
Caulk around windows

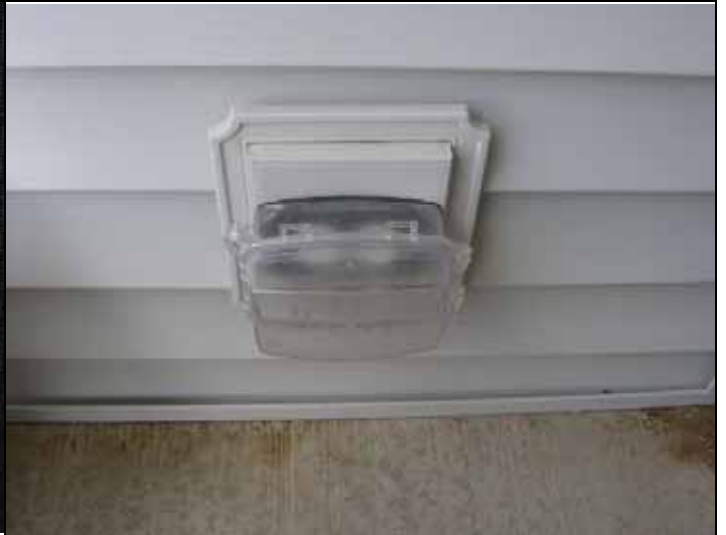
Loose outlet in entrance area

2. Wiring in garage is exposed and subject to physical damage. The wiring should be covered or run in conduit.
3. The exterior outlet in the entrance area was loose.

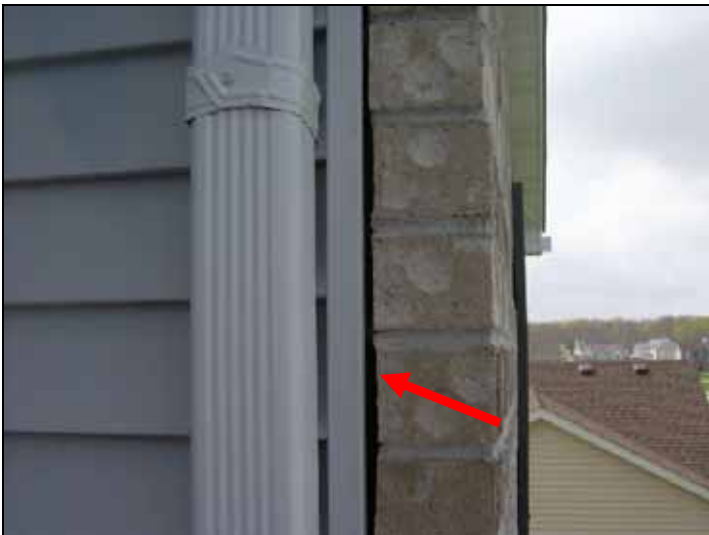
Fill gaps

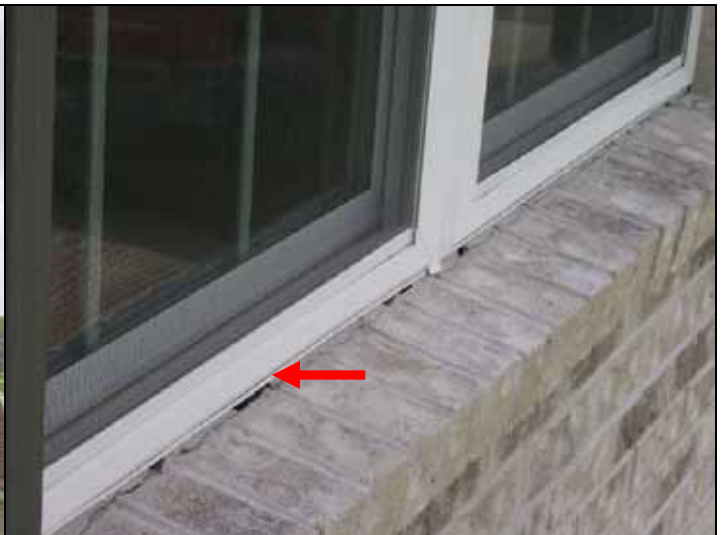
Caulk needed

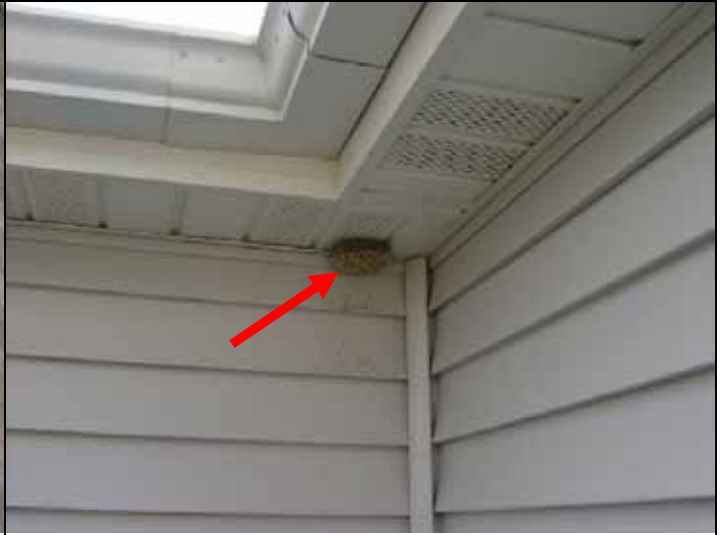
Wasp nest

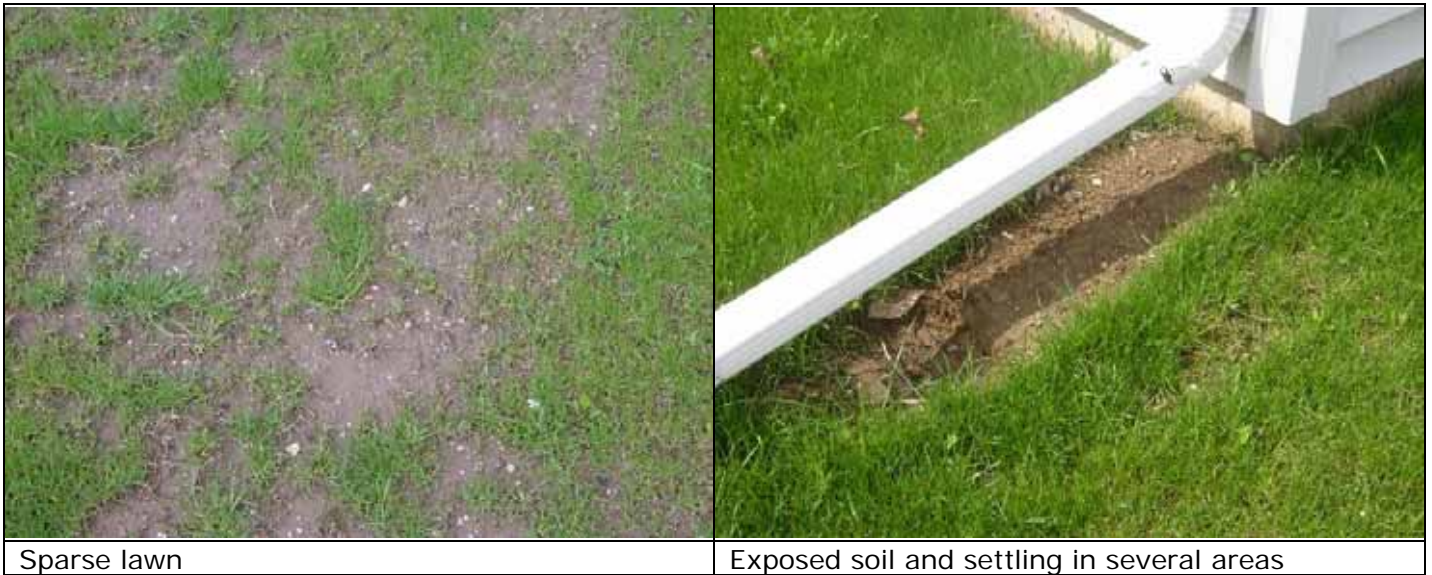
1. The home had a very sparse lawn and the soil was very soft around the foundation. As with most new homes there will be settling around the foundation and else ware in the lawn as the soil settles. Fill any depressions around the foundation and be sure to maintain a slope away from the foundation to direct surface water away.

Sparse lawn

Exposed soil and settling in several areas

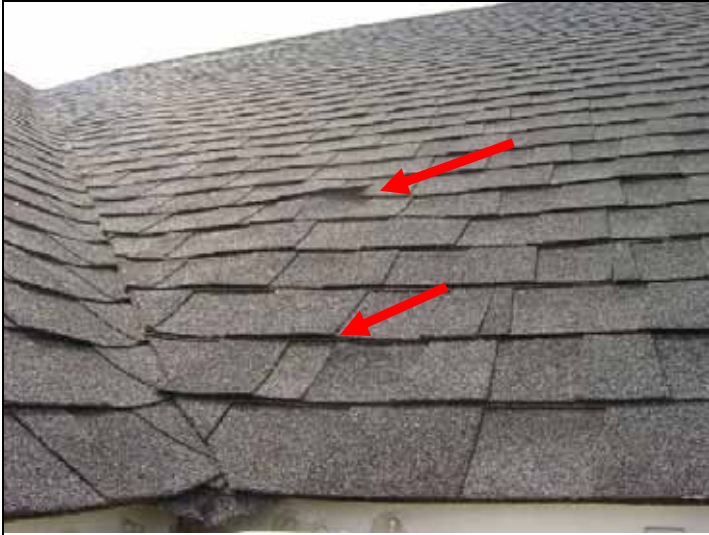
1. The roof exhibited several signs of sloppy workmanship. The edges and valley cuts were jagged and there was nails and debris on the roof and in the gutters. There was one complete shingle missing and several others that were not laying flat. There were some staples exposed and others that were not driven to proper depth or have backed out. The roof had no underlayment installed. Typically tar paper is used and acts as a second line of defense for leakage and acts as a release to prevent shingles from adhering to plywood deck. The wood and shingles expand and contract at different rates and if there is no release underlayment it can shorten the life of the roof covering. Many shingle manufacturers void the warranty if no underlayment is used. The roof was stapled rather than using roofing nails. This method of attachment is not the preferred method by most manufacturer standards and may void warranties of some manufacturers. Have the shingle replaced immediately and have a roofer examine the roof and repair any popped staples. Check the manufacturer's specifications for installation and warranty. Because of lack of underlayment the roof covering will likely need to be removed and replaced.

Several shingles not sealed, staples popped

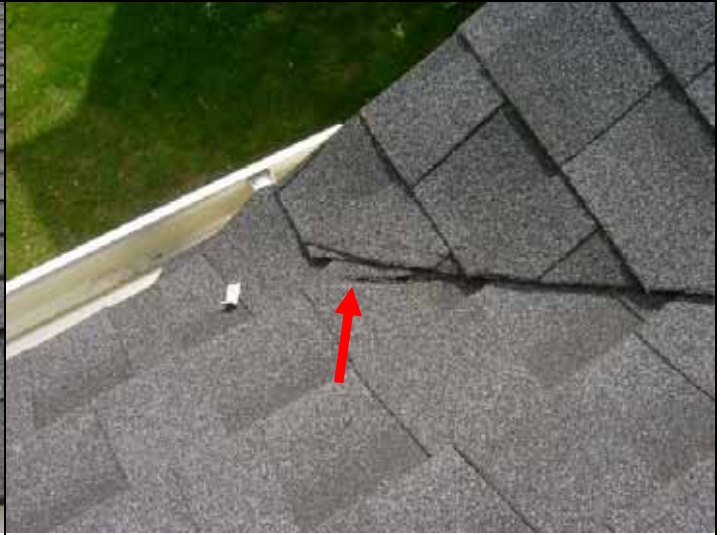
Loose shingles, sloppy cuts

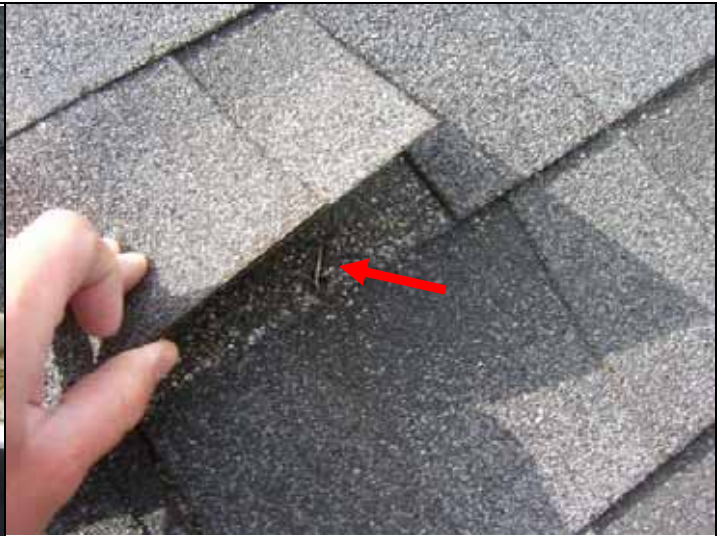
Popped staple

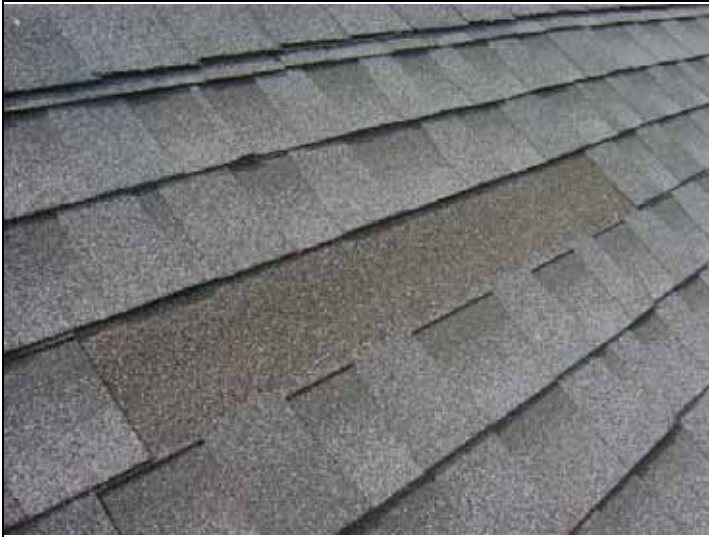
Missing shingle

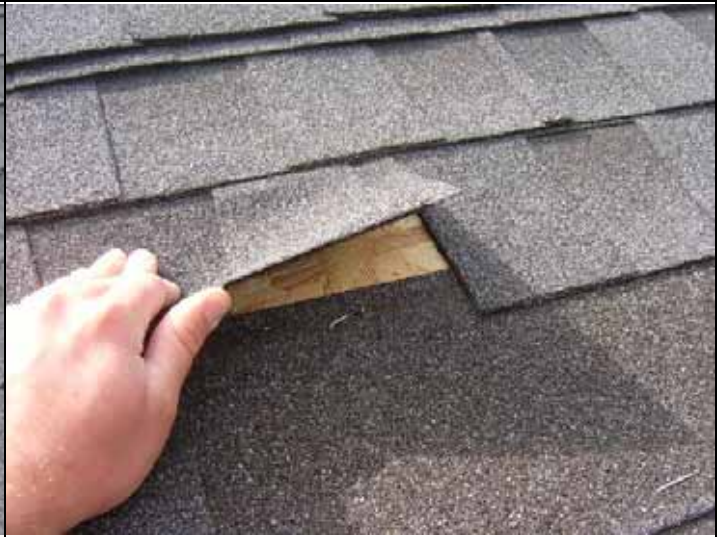
Leakage can occur, no underlayment

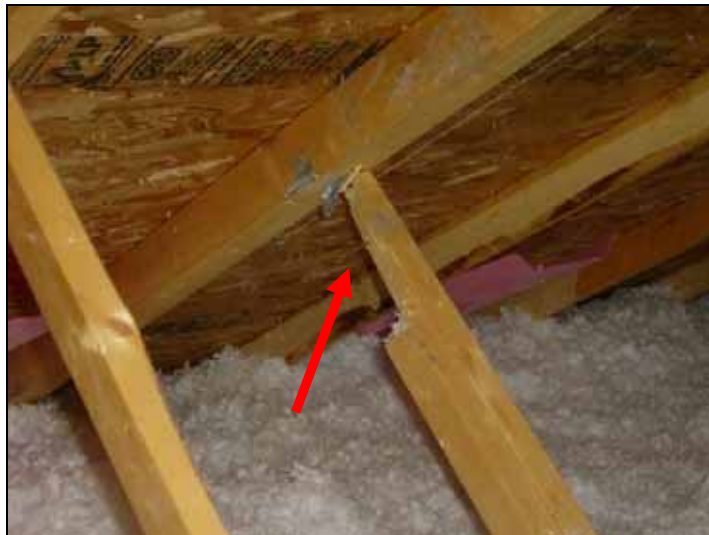
Truss cord was damaged and will need to be replaced.

1. A truss cord in the attic was damaged and will need to be replaced.

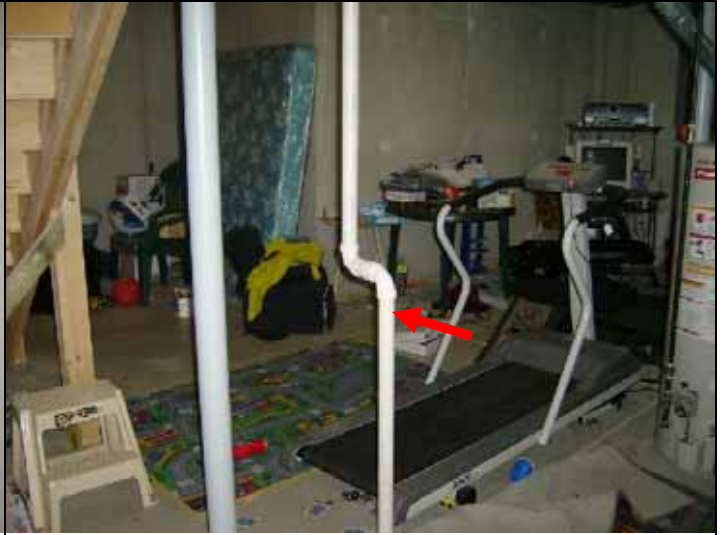
Waste pipes subject to damage.

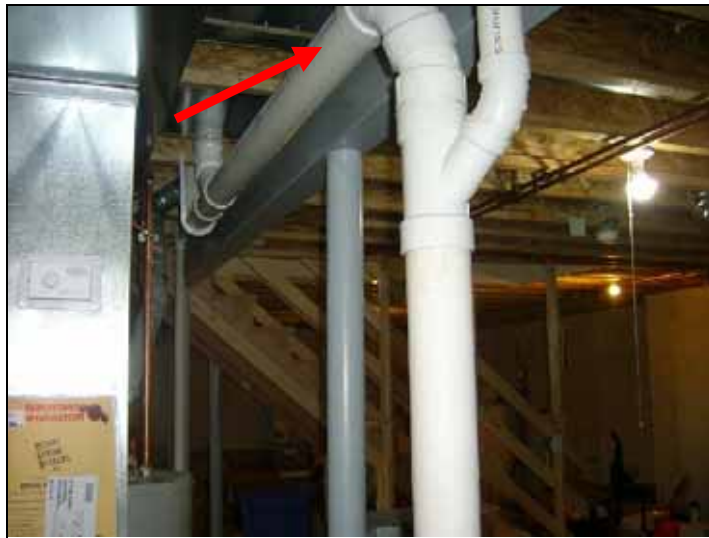
Additional support needed

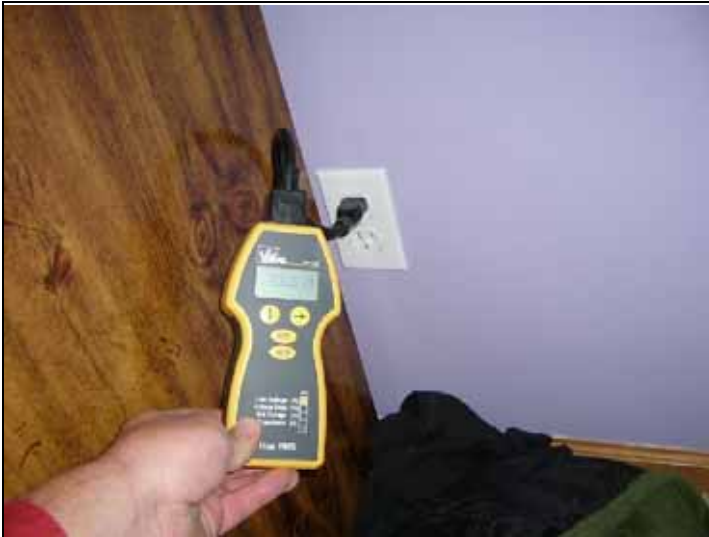
1. Testing a sample amount of outlets revealed an inconsistent voltage drop under load. When a 15-amp load was applied to the circuit the line voltage dropped 8-12.5% any voltage drops over 5% are considered out of acceptable range per manufactures standards. The most common causes for this are excessive length of the wire in the circuit or poor connections. The connections most often responsible are push-in type receptacles. This wiring method (also called speed wiring) is acceptable by NEC code, but often results in poor connections. The solution to this is using the screw type terminals for a better connection. This condition needs to be further evaluated by a qualified electrician to determine the quality of connections.

12.5% voltage drop

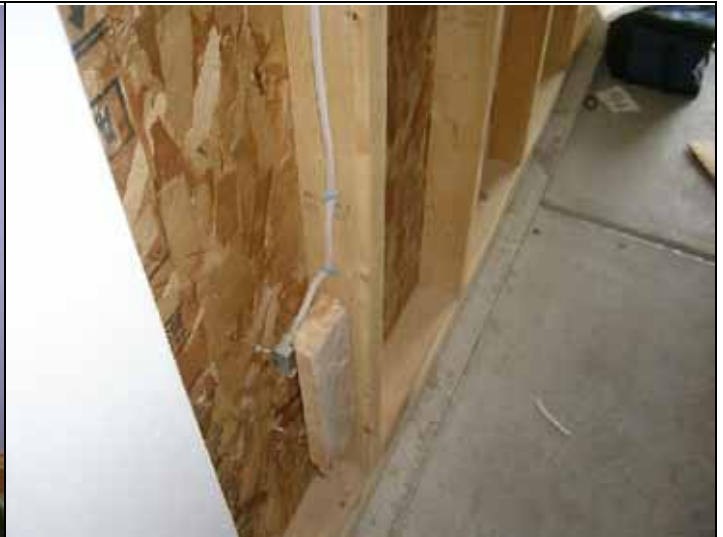
Exposed wiring in garage

1. The wiring in garage should be covered to prevent physical damage to wires.
